TECHNICAL REPORT ARCCB-TR-98014

**FAILURE ANALYSIS OF AN 84-MM, M3,  
CARL GUSTAF, RECOILLESS RIFLE**

JULY 1998

**US ARMY ARMAMENT RESEARCH,  
DEVELOPMENT AND ENGINEERING CENTER  
CLOSE COMBAT ARMAMENTS CENTER  
BENÉT LABORATORIES  
WATERVLIET, N.Y. 12189-4050**

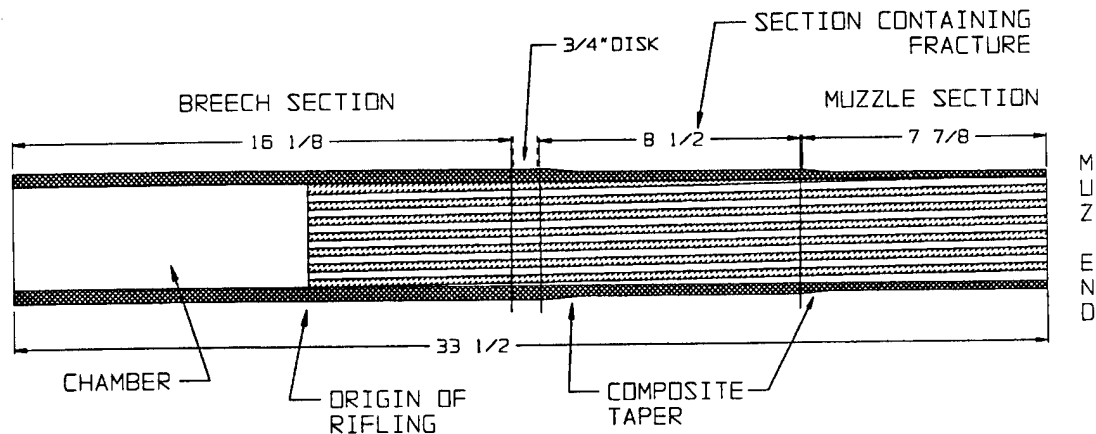
Figure 2. Barrel specimen cut location sketch

The barrel was cut into several sections, as shown in Figure 2. A 16.125-inch long, breech fatigue specimen was cut from the barrel for possible use in the Multi-Role, Anti-Armor, Anti-personnel Weapon System (MAAWS) Gun Life Study. The section from the muzzle to a distance of 8 inches into the barrel was also sectioned off and set aside. The failure zone, which included 8 inches from the muzzle point to a distance of 16.5 inches from the muzzle, was removed and cut in half lengthwise (from 1:00 to 7:00) to expose the liner crack for analysis. The small remaining section was polished on one side and used to measure liner thickness and evaluate laminate and liner quality. Before cutting, a piece of tape was placed over the liner crack on the bore surface to capture any debris that may have fallen out during the cutting operation.

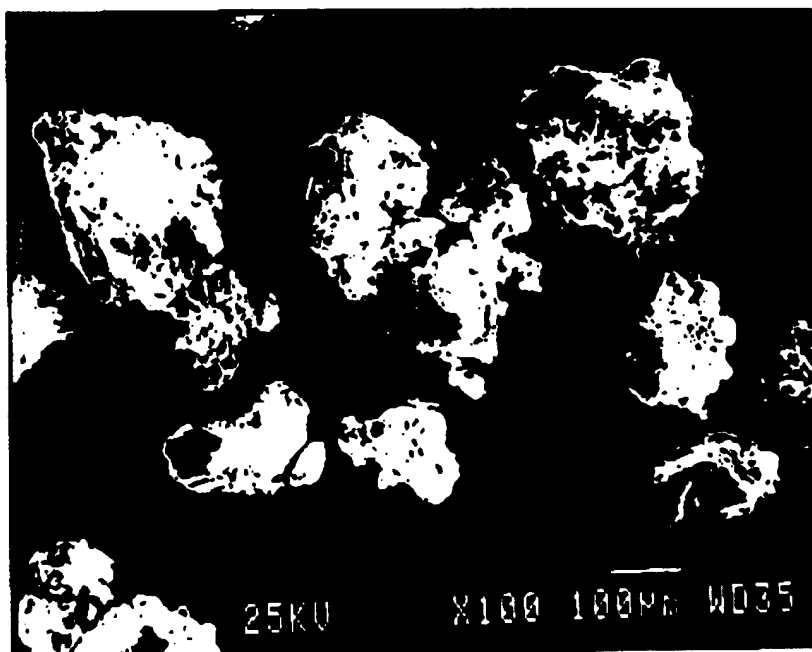
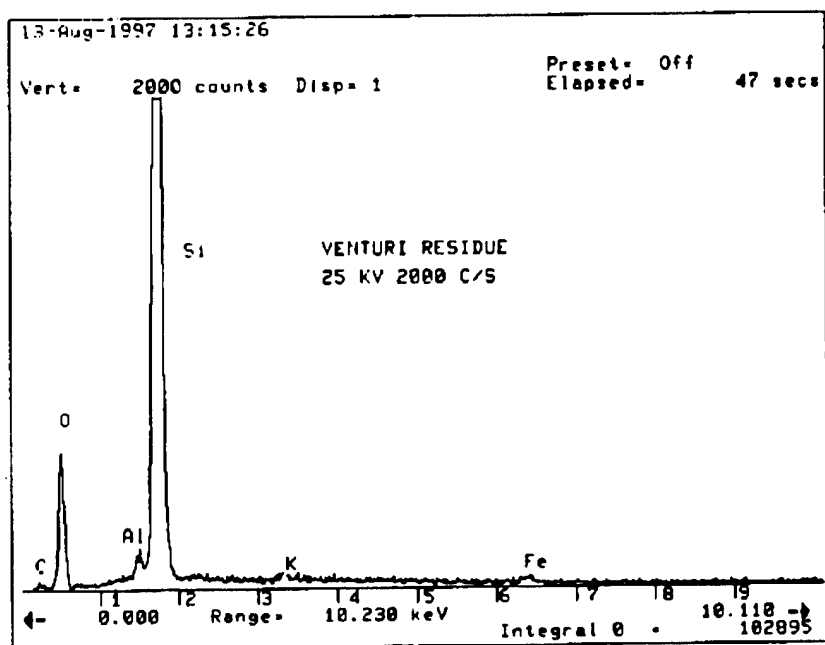
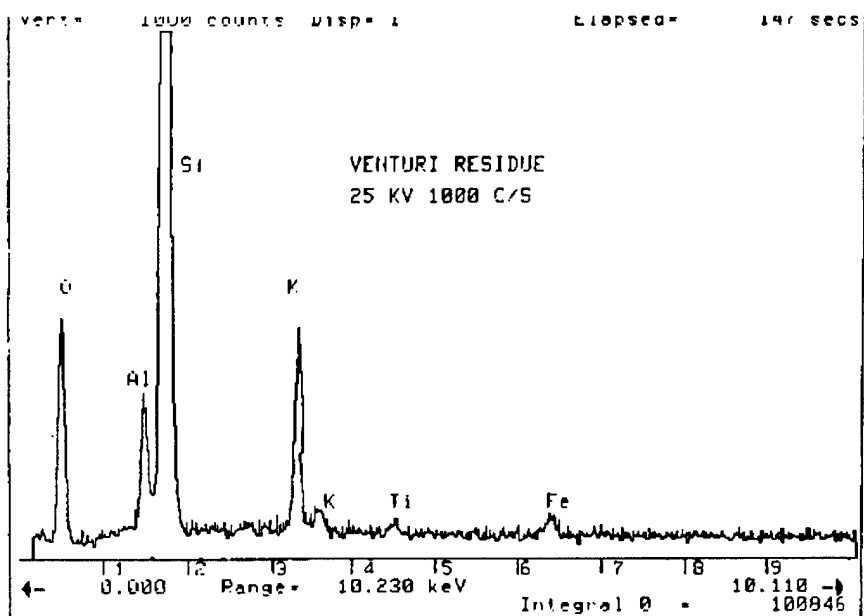
**FIG.#1**

1. The rifle bore had debris and particles in and around the 2.5" longitudinally-oriented bore crack. Most of these particles were white and/or cream colored, but some of the debris on the breech side of the crack was red. Particles were removed *in situ* (via plastic tape) from the crack and from the surrounding regions prior to sectioning for SEM/EDX analysis. No chemicals were used in the extraction.

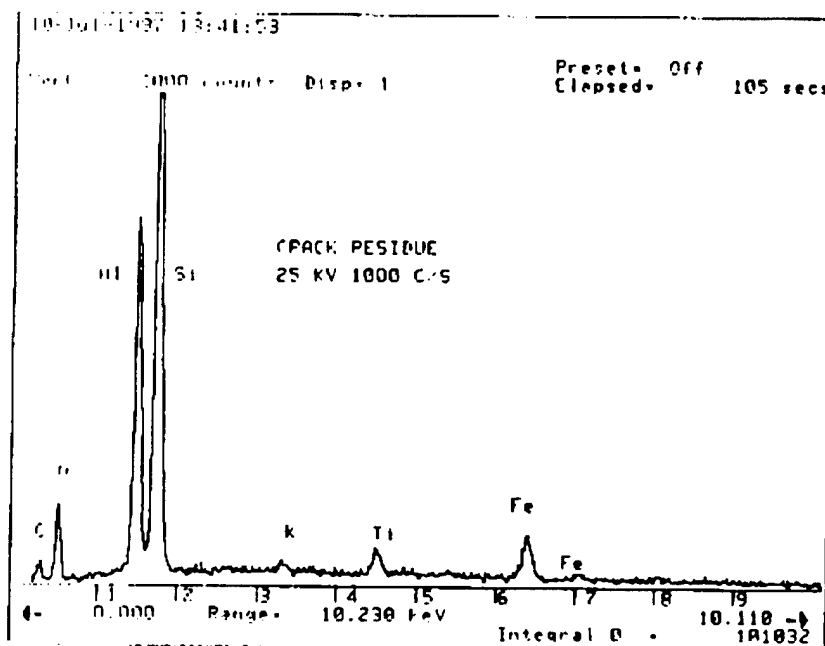
**FIG. #2**

2. Figure 2 shows material that was extracted *in situ* from a portion of the liner crack before sectioning. Figure 2A is an "elemental map" of the same area and shows the extracted particles to be rich in Si. The EDX spectrum from this material (shown in Figure 2B) indicates a strong Al presence. Many extracted particles were equiaxed, but others appeared to be film-like. Figures 3 and 3A show large particles near the crack that were also rich in Al and Si. EDX spectra from equiaxed particles were always rich in Si and/or Al.

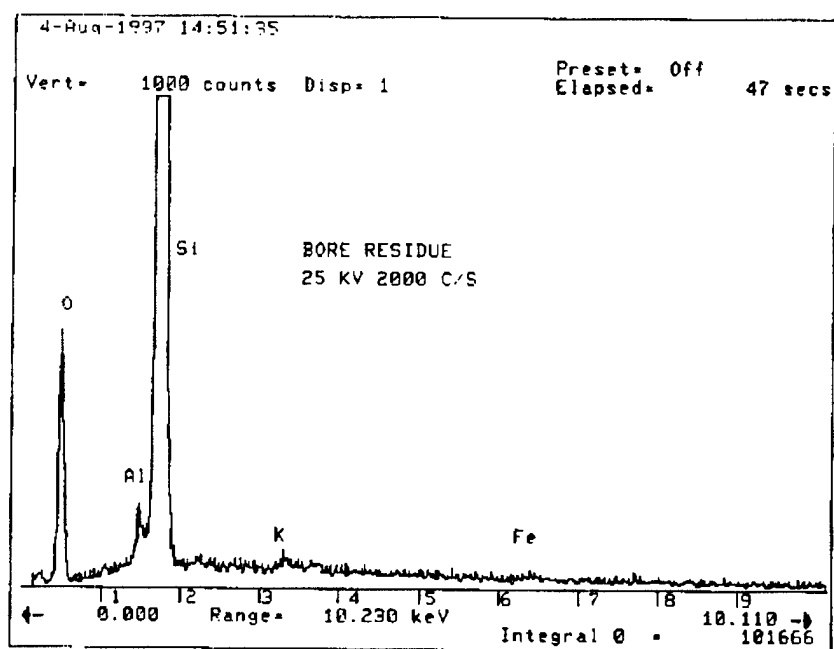
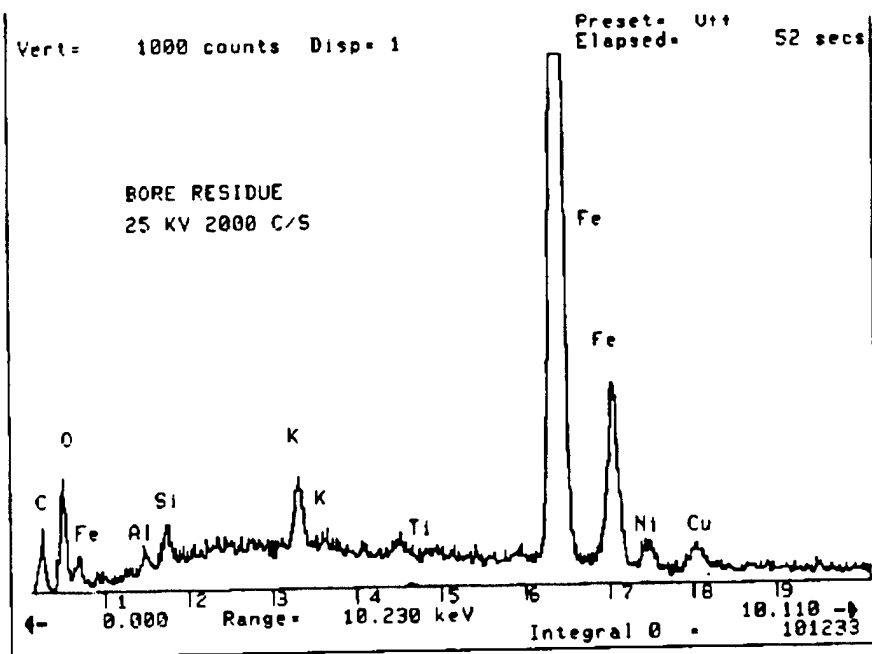
**FIG. #4**

Figures 4 through 4D are from particles that were extracted from the liner on the breech side of the crack. This area displayed a reddish appearance. Figure 4 shows a land/groove junction, while Figures 4A and 4B are Si and Fe maps, respectively, from this same area. The pictures show that large, equiaxed, Si-rich particles were concentrated in the

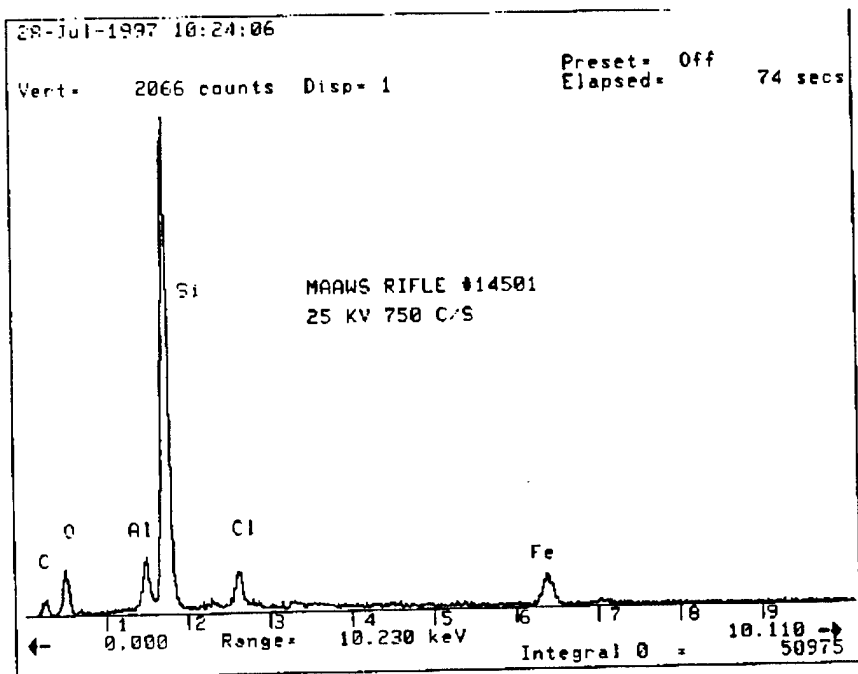
**FIG. #5**

3. The cracks on the composite outer diameter and the liner inner diameter were protected with plastic tape while the liner crack was cut to fit into the SEM. (During this cutting, the composite delaminated from the liner.) Figures 5 and 5A show a portion of the liner crack after sectioning. Figure 5 shows debris *in* the crack, while Figure 5A shows the debris to be rich in Si. The crack showed no evidence of brittle fracture.

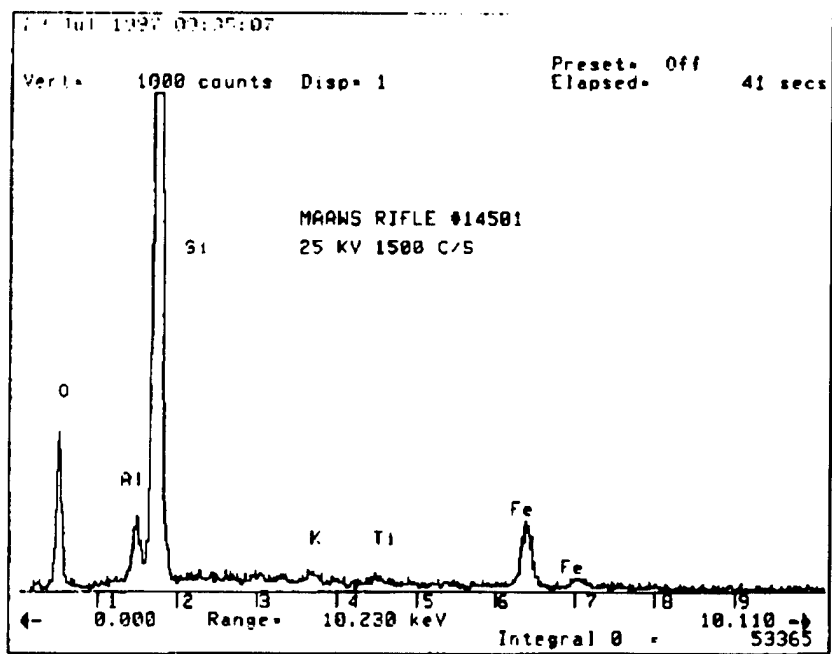
**FIG. #6**

4. The crack was then "broken open." Figure 6 shows a typical fracture surface (F), with debris still covering much of the separation. This debris was consistent with silica (Figure 6A). The debris was removed via tape to reveal the fracture mode. Figure 7 shows a typical fracture surface (F), while higher magnification (Figure 8) shows the fracture mode to be shear, which is consistent with a single cycle, tensile overload.

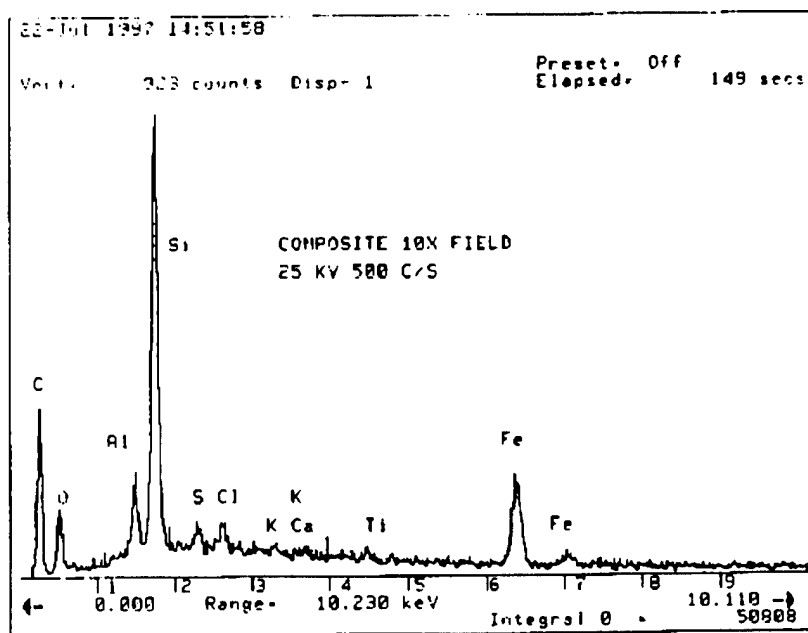
**FIG. #9**

5. Figures 9 and 9A show a portion of the crack in the composite, at what had been the composite/liner interface. The elemental map in Figure 9A and the EDX in Figure 9B reveal Si-rich material in and around the crack. EDX analysis of the particle-free composite showed only material consistent with the composite.
